Manhole Inspection Summary

Manhole # S31K__026MH

Insp Date: **12/24/08 9:08 AM**

Location Address: **618 Washington BD**

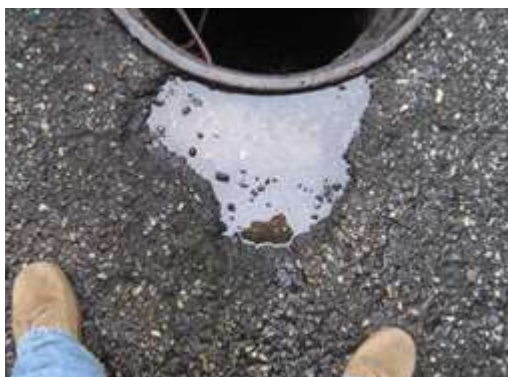
Miscellaneous

standing water

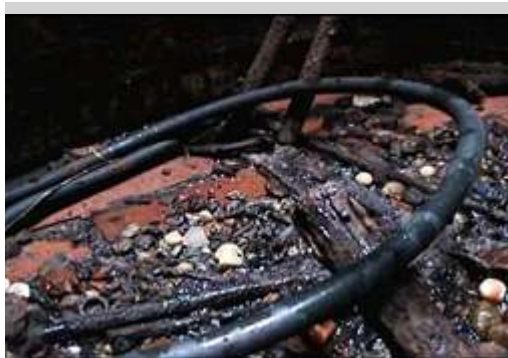
Defect 4

Condition: ☐ Sound ☐ Cracked ☐ Root Intrusion ☐ Deteriorated ☐ Leaks ☒ **Debris**

channel debris

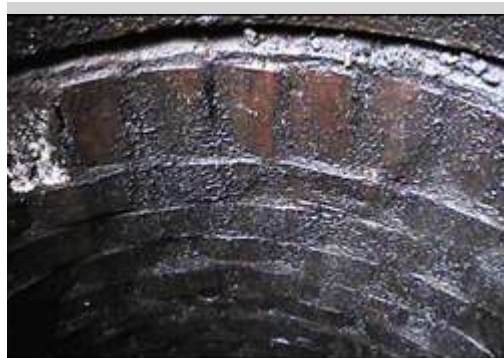
Defect 6

Condition: ☐ Sound ☐ Cracked ☐ Root Intrusion ☒ **Loose Brick** ☒ **Deteriorated**

Infiltration: ☐ None ☒ **Joint** ☐ Cracks ☐ Mortar ☐ Roots ☒ **Wall**

deteriorated chimney with loose brick & infiltration from joint & wall

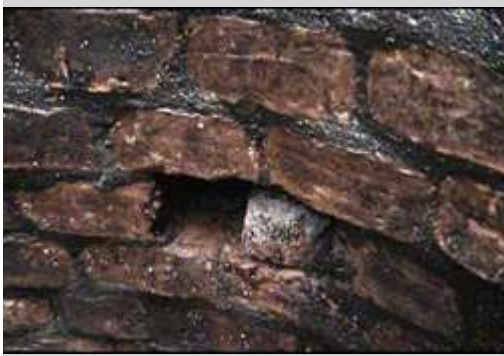
Defect 5

Condition: ☐ Sound ☐ Cracked ☐ Root Intrusion ☒ **Loose Brick** ☒ **Deteriorated**

Infiltration: ☐ None ☐ Joint ☐ Cracks ☒ **Mortar** ☐ Roots ☒ **Wall**

corbel, loose missing brick, deteriorated, infiltration at wall & mortar

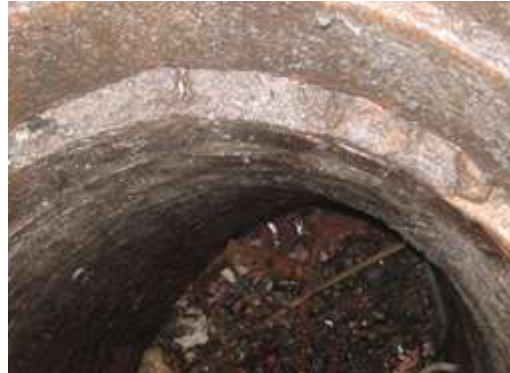
Defect 3

☒ **Leaks**

frame infiltration at cover

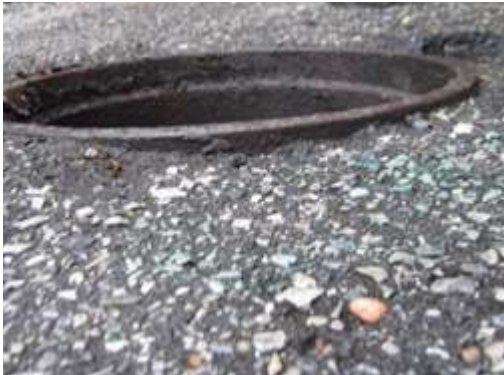
Defect 1

cover above pavement 1 inch

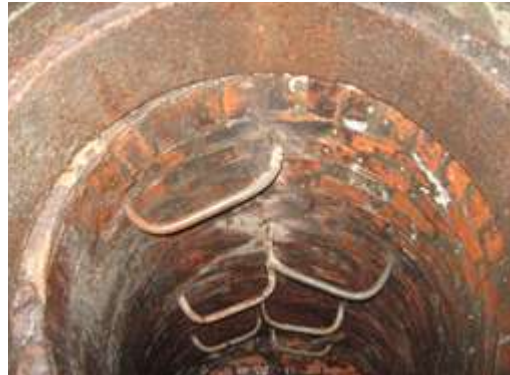
Defect 2

Frame Offset: **1** (in.)

frame offset 1.5 inches

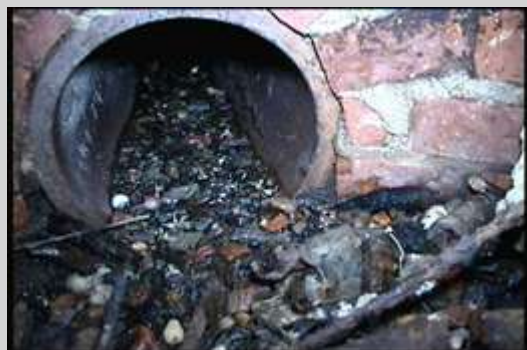
12 O'Clock Outflow

Deposits: ☐ None ☐ Mud ☐ Sludge ☒ **Debris** ☐ Grease

Silt Depth: **1** (in.) Deposits Extent: **Medium**
